# RPAS operations CYVR

# Uses of drones at YVR

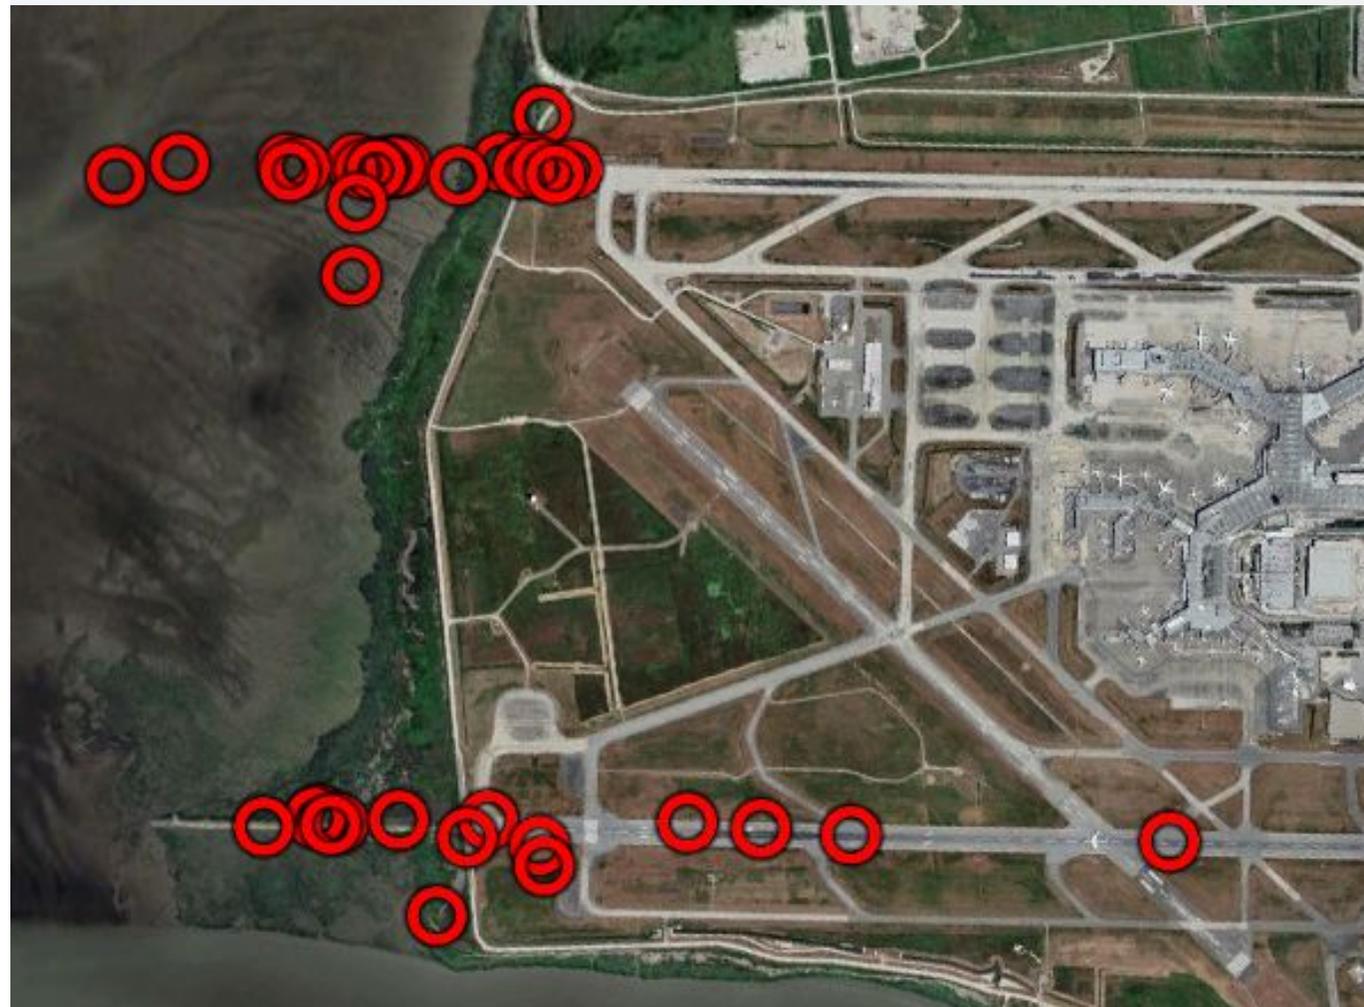
**Snow Goose strike & near miss locations:  
Oct 2019 to January 2022**

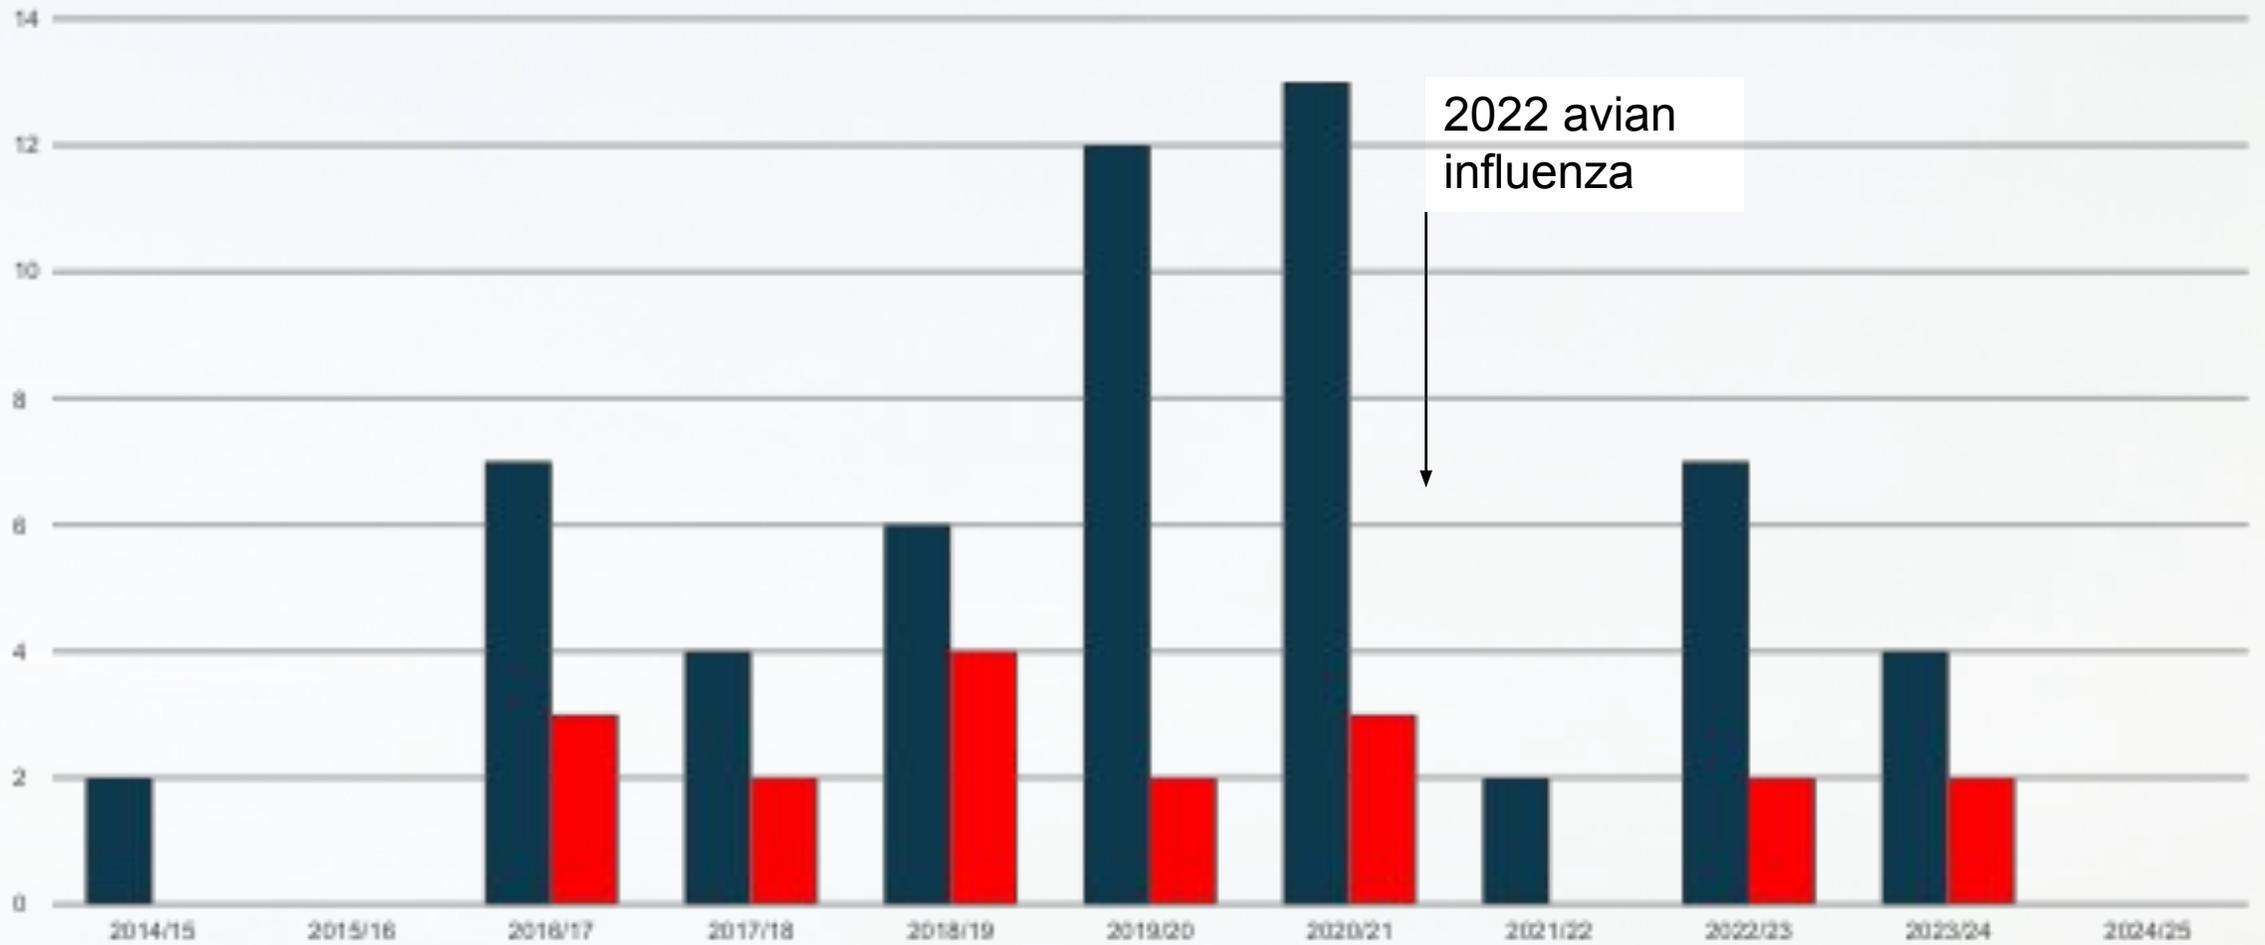
# Count of strike incidents involving Snow Geese, by winter period: 2014/15 to 2024/25

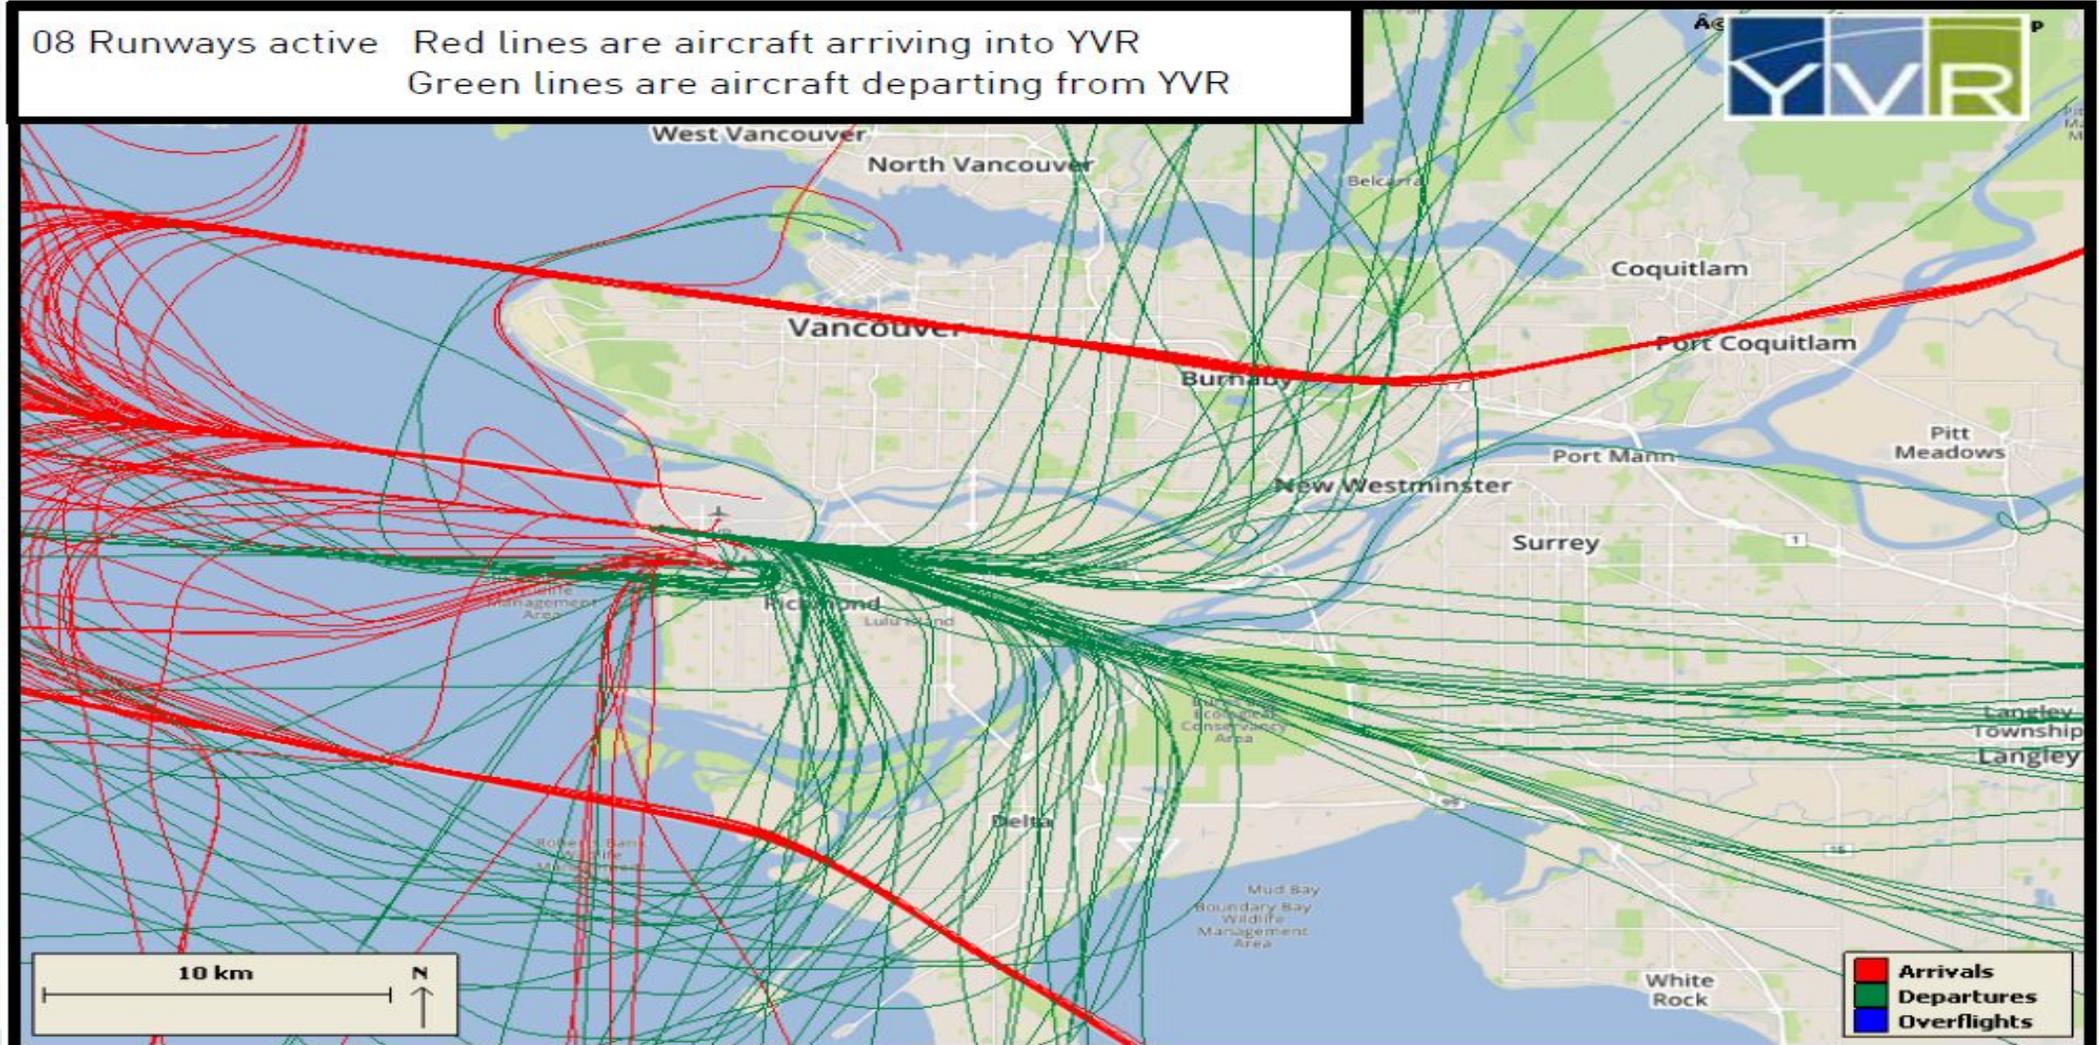
# Runway configuration 08

08 Runways active Red lines are aircraft arriving into YVR  
Green lines are aircraft departing from YVR

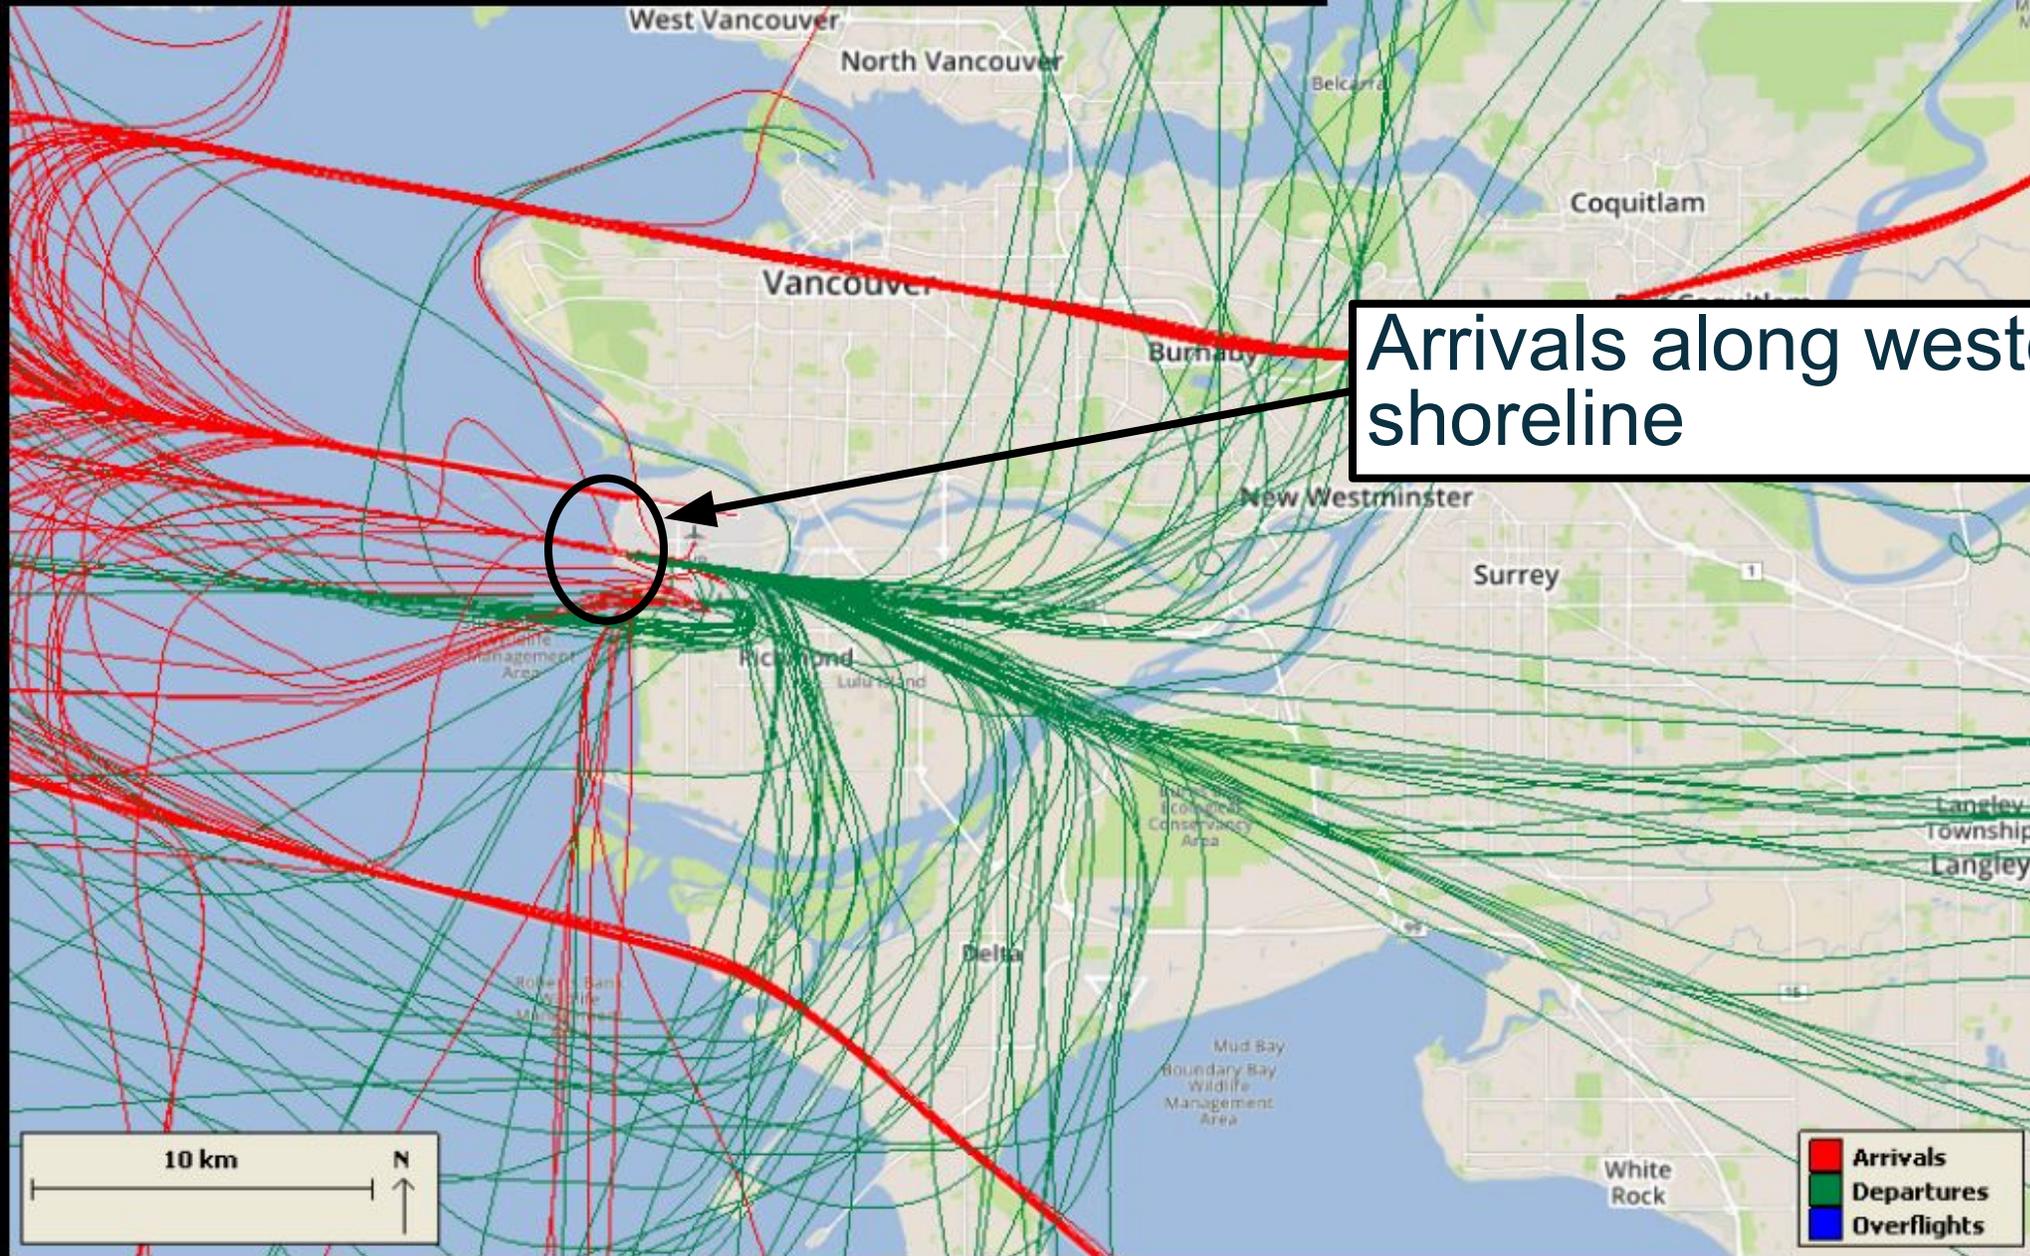
Arrivals along western shoreline

- Arrivals
- Departures
- Overflights

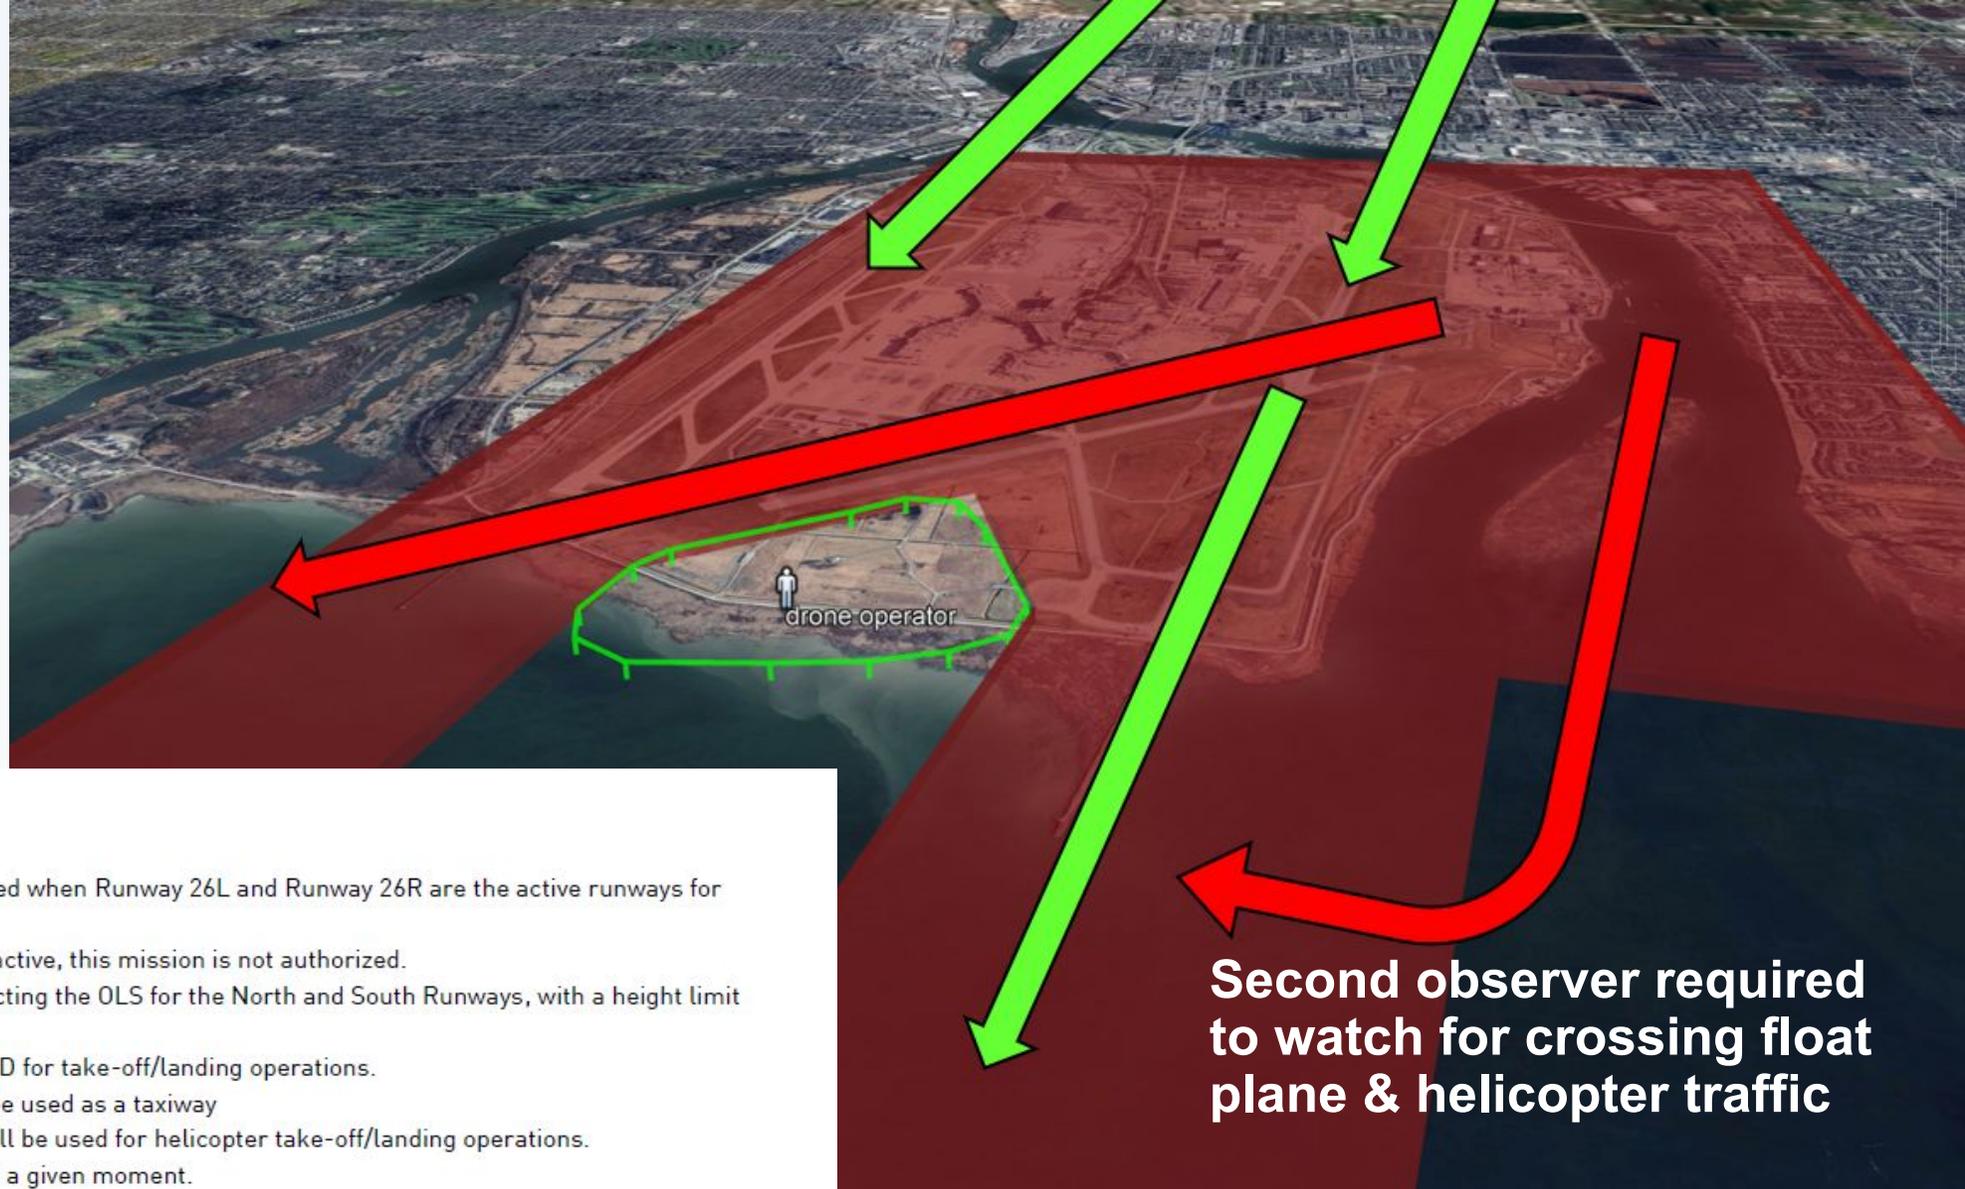
# Drone ops restricted to 26 (westerly flow) operations

- This RPAS mission can only be activated when Runway 26L and Runway 26R are the active runways for departures and arrivals.
- When Runway 08L, 08R, 13, or 31 are active, this mission is not authorized.
- The Geo Fence must be in place protecting the OLS for the North and South Runways, with a height limit of 147 ft AGL (45m).
- Runway 13/31 must be NOTAM CLOSED for take-off/landing operations.
  - Note: Runway 13/31 can still be used as a taxiway
  - Note: Runway 31 THLD can still be used for helicopter take-off/landing operations.
- Only 1 RPAS is permitted to operate at a given moment.

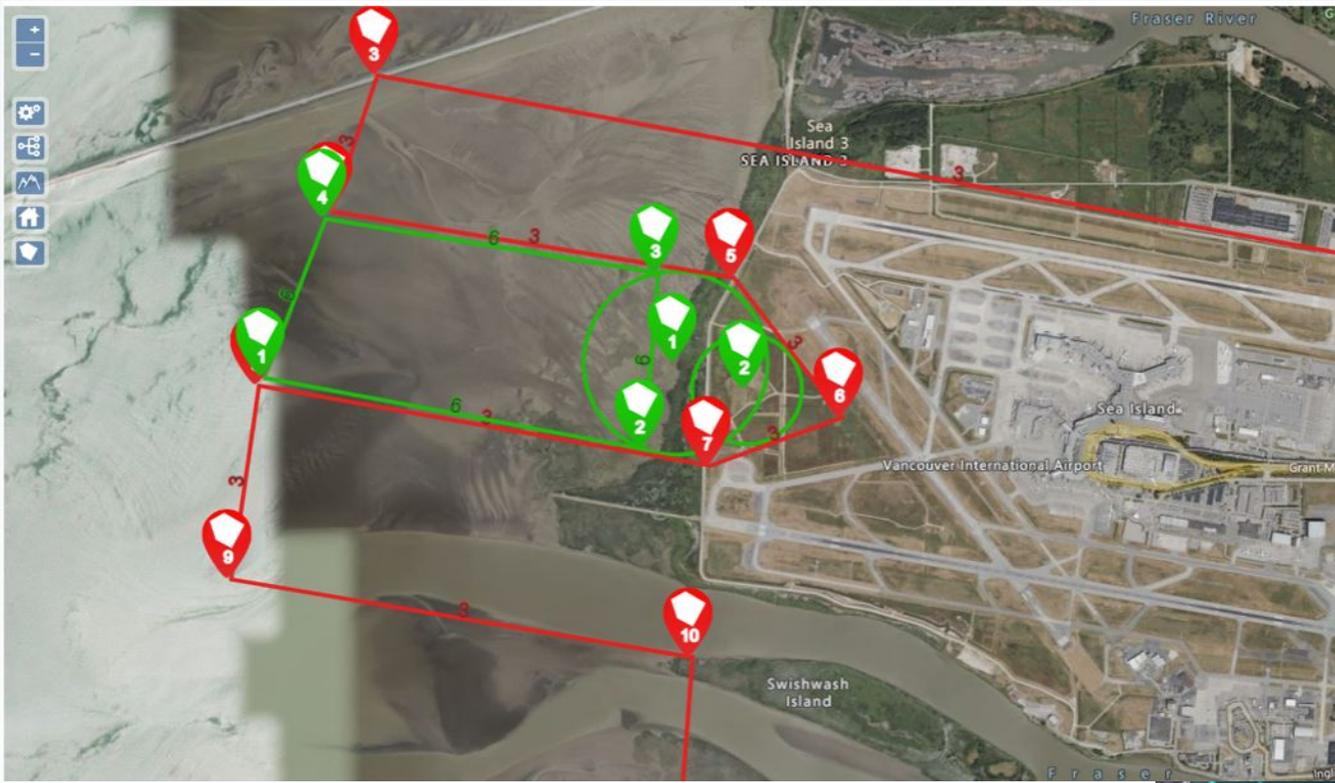
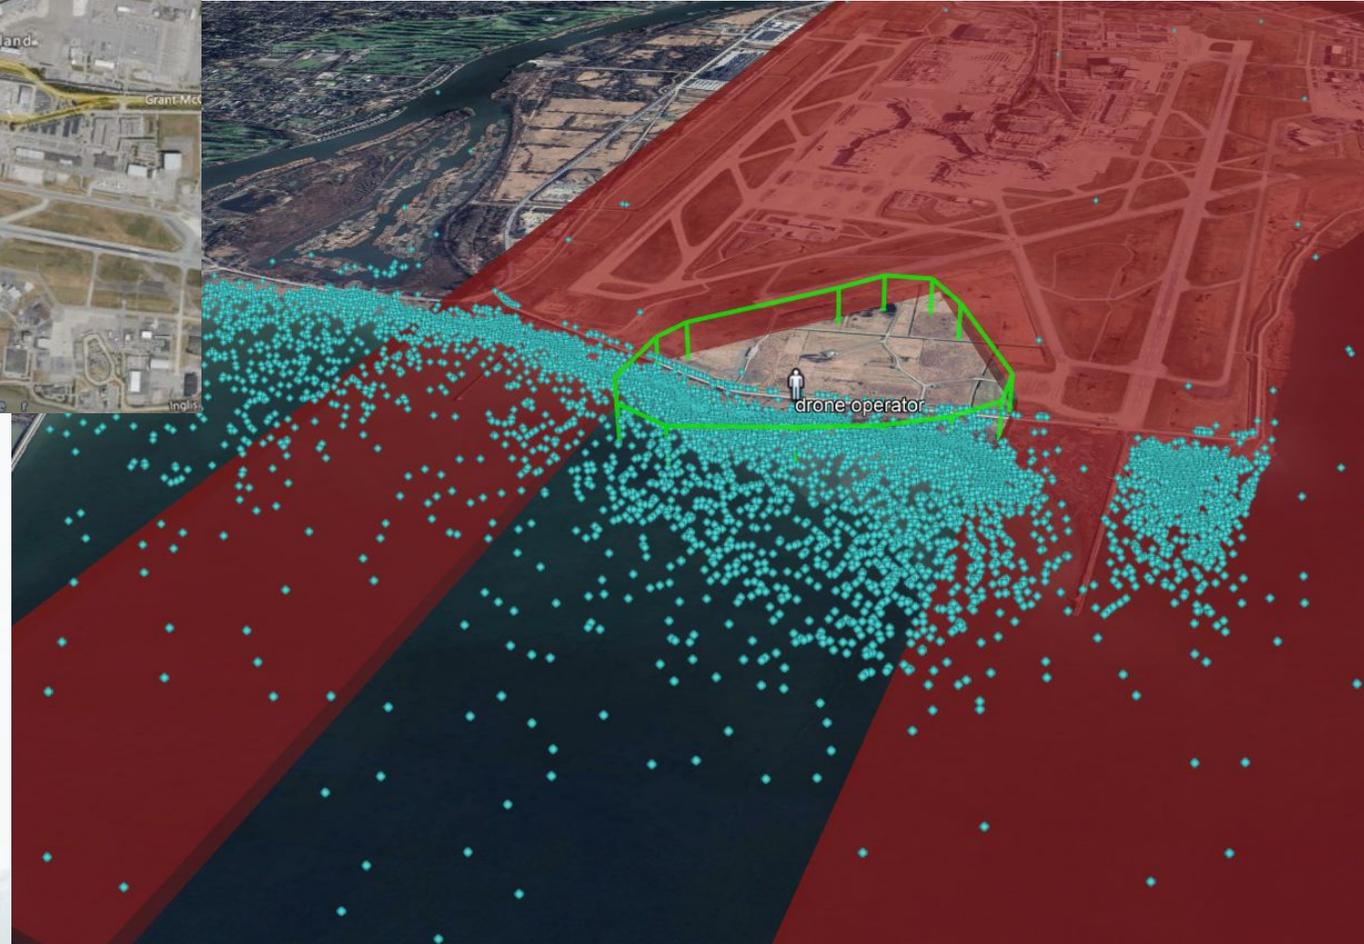
**Second observer required to watch for crossing float plane & helicopter traffic**

**Geofences required to keep drones in prescribed operating area**

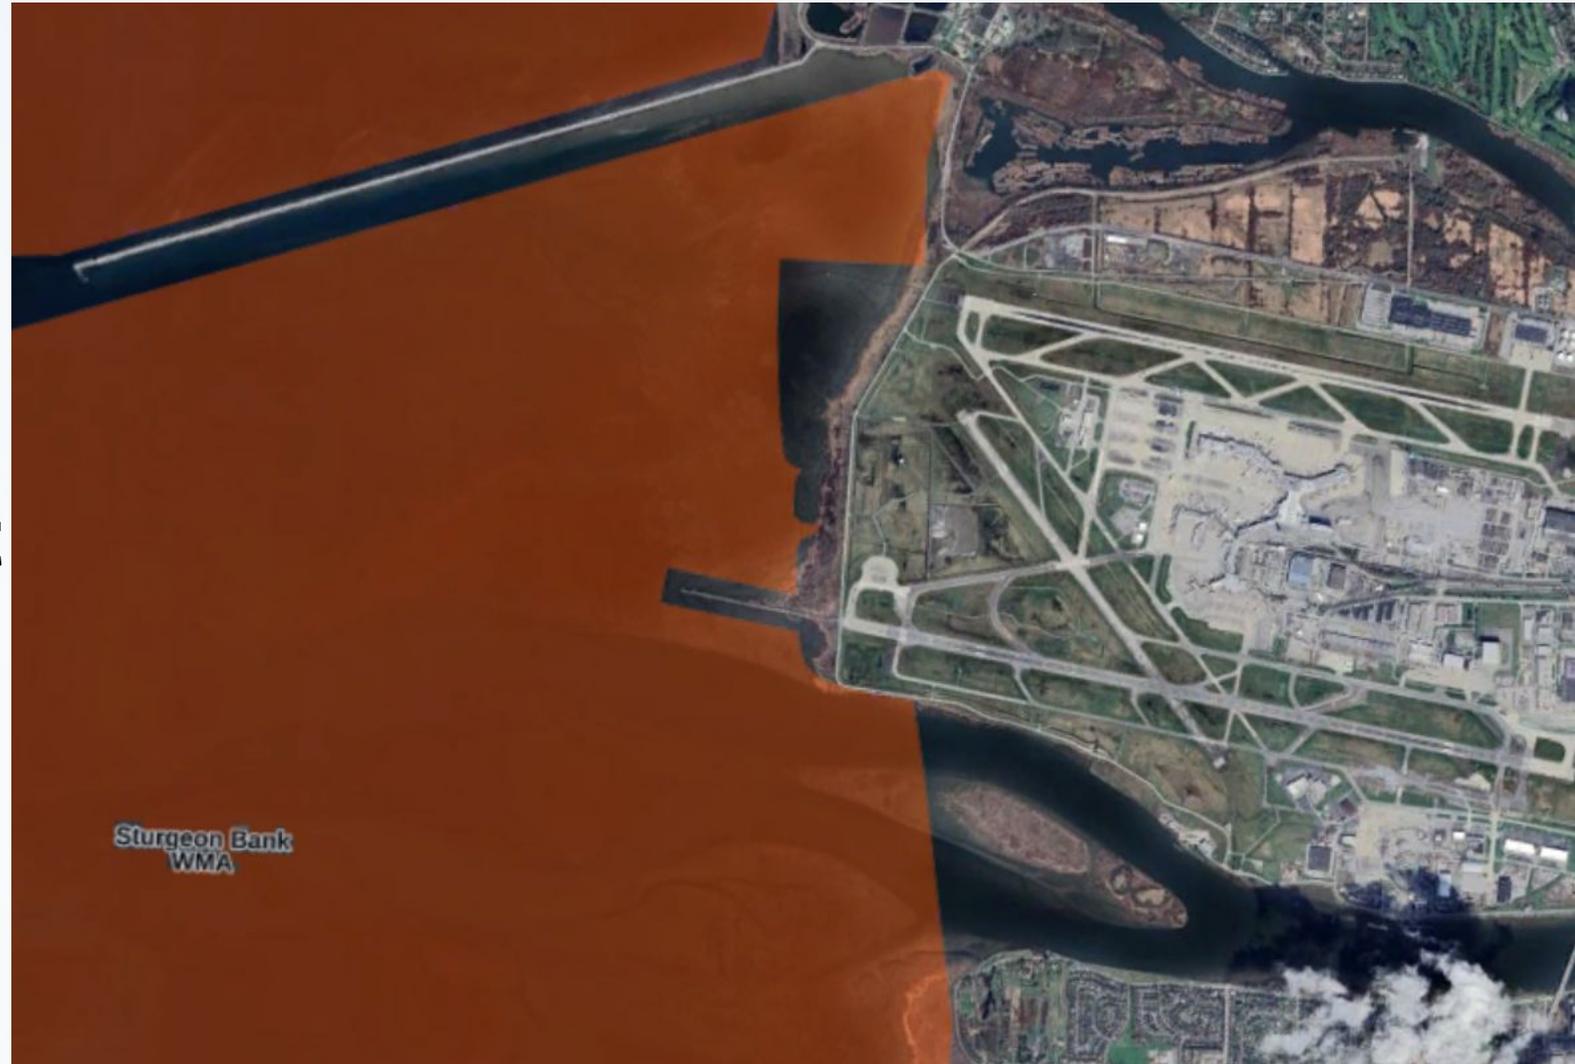
**Phase 1: Initial test flight with quadcopter 'restricted' geofence**

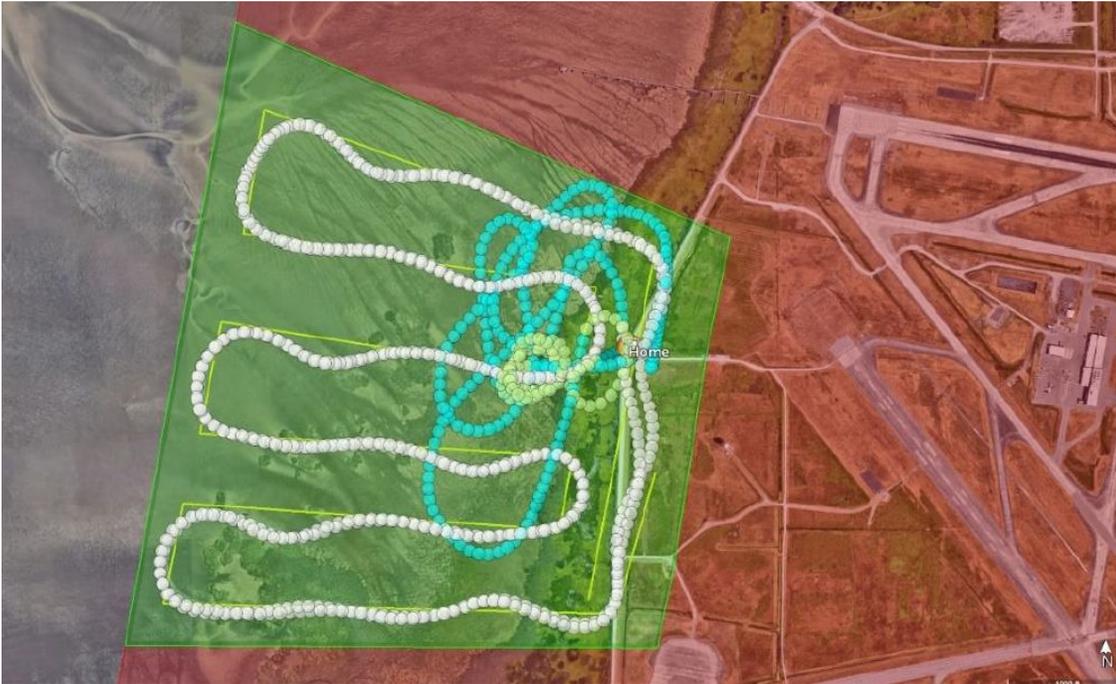
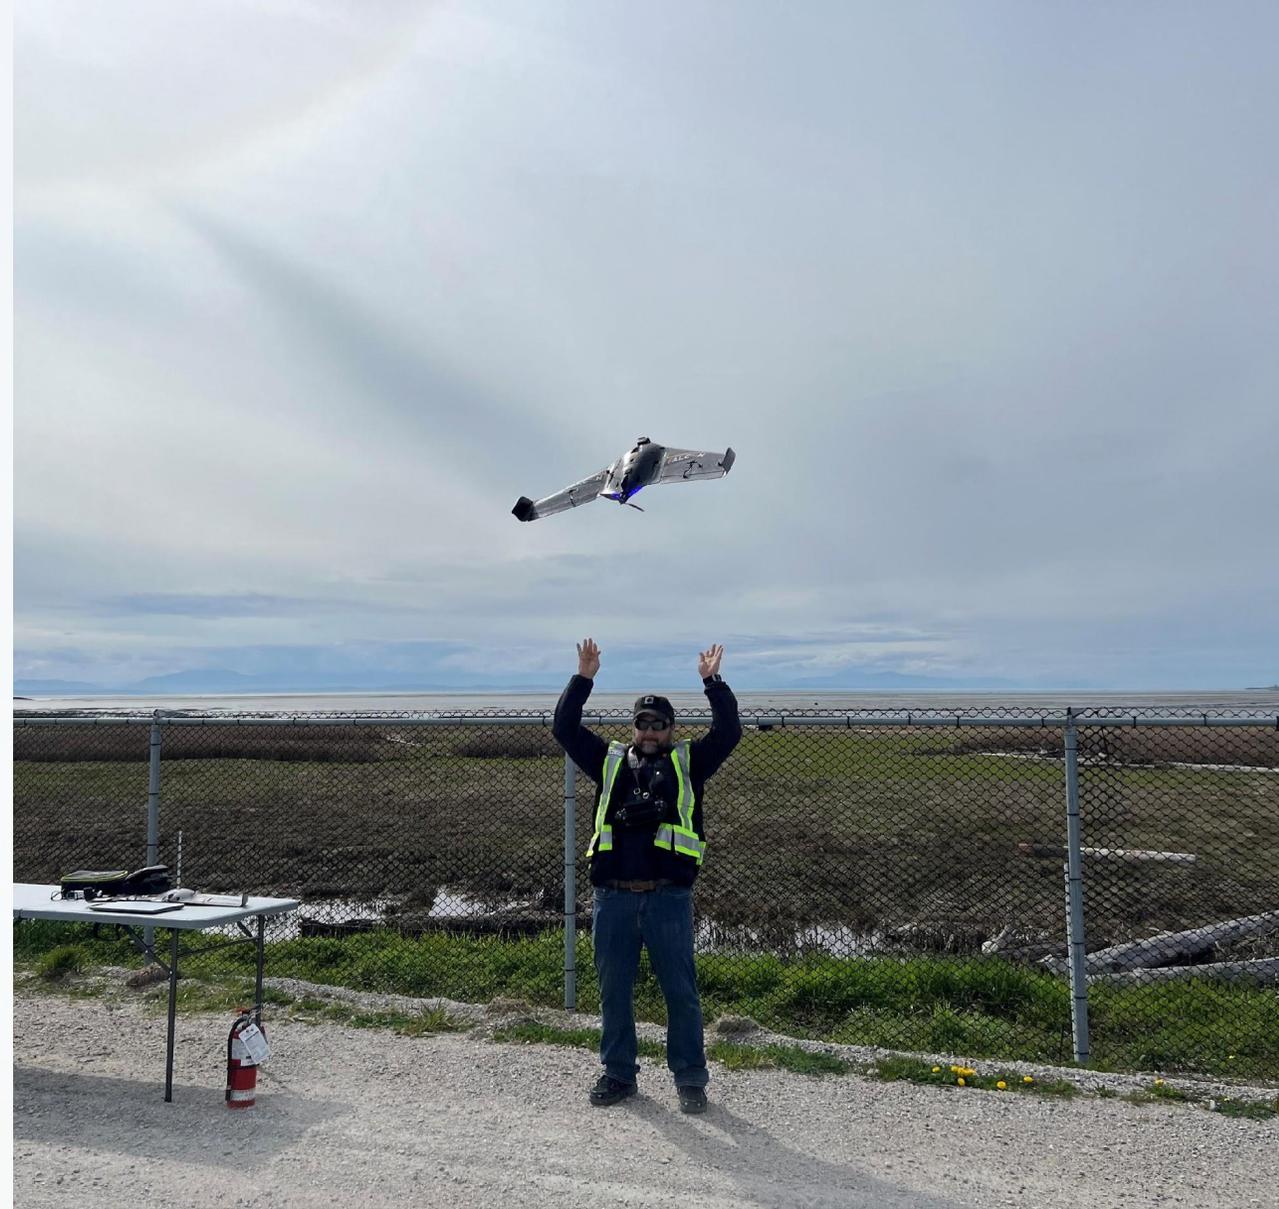
**Phase 2: fixed-wing 'restricted' geofence**

**Phase 3: fixed-wing 'expanded' geofence, and**

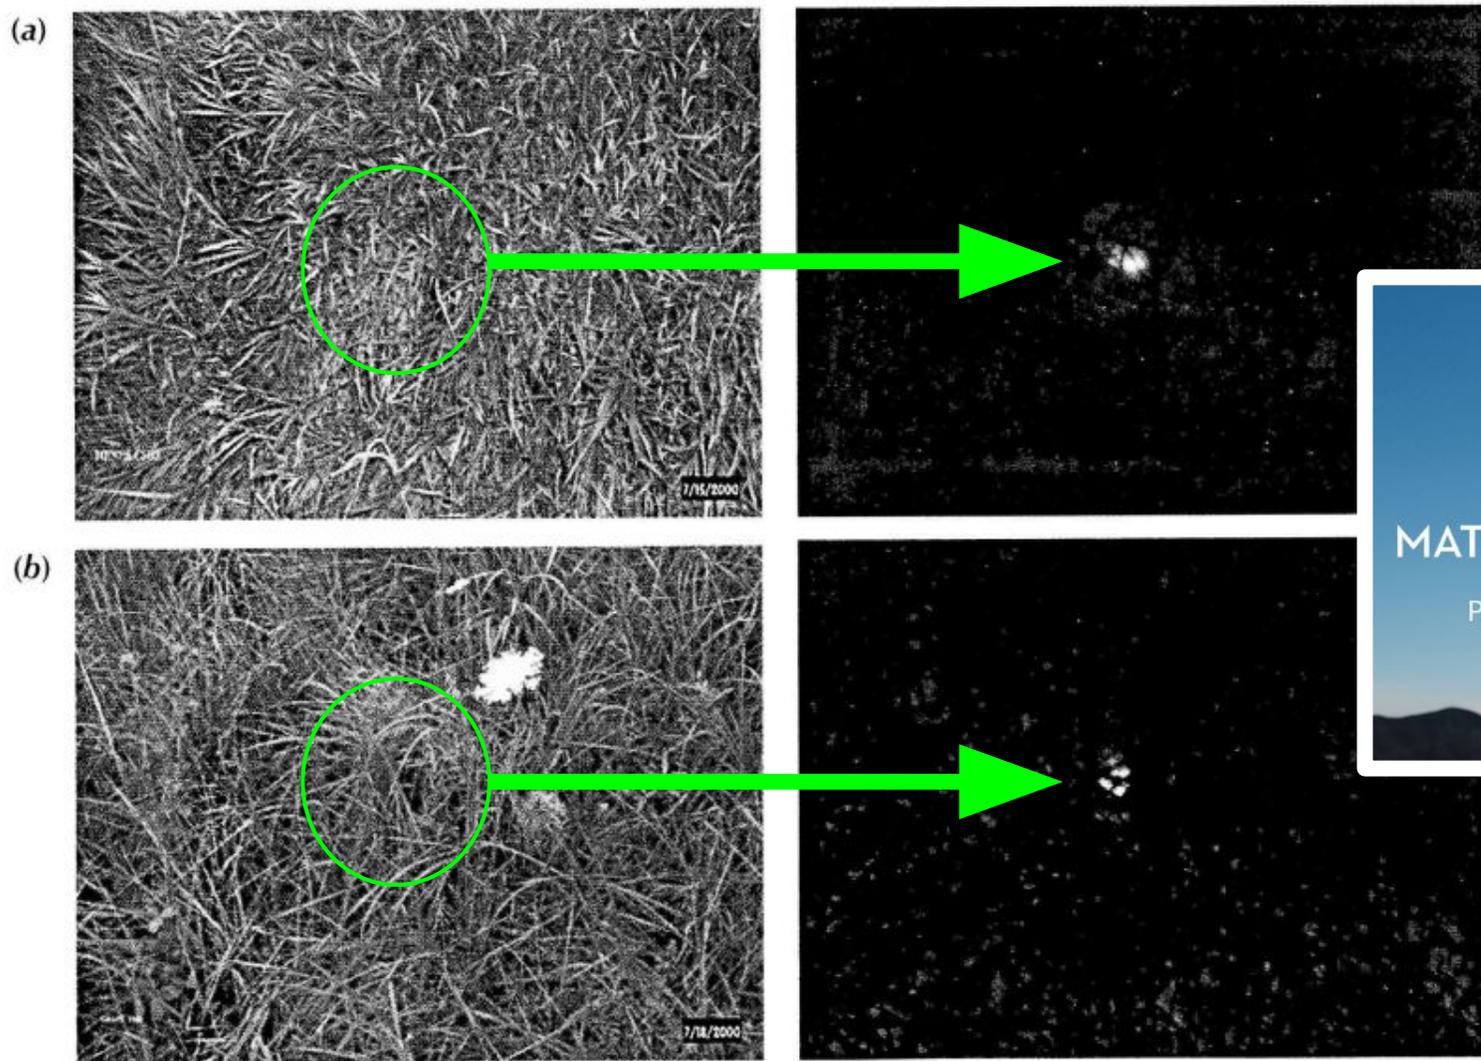
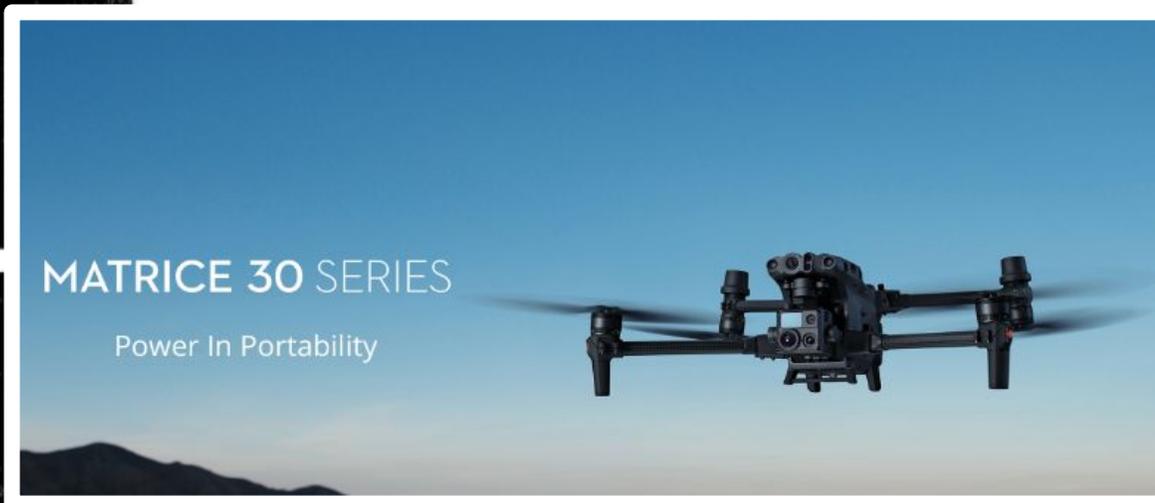
Figure 1. Visual and thermal images of a Henslow's sparrow nest (a) and a grasshopper sparrow nest (b). Both line-of-sight images were taken from about 2 m away from the nest. The temperature range of the Henslow's sparrow nest image was between 28.3°C (yellow-white) and 18.8°C (dark-purple). The temperature range of the grasshopper sparrow nest was between 23.3°C and 17.9°C. Both thermal images are as they appeared during the field search in the imager's viewfinder.
